# Manhole Inspection Summary

Manhole # S19I\_\_029MH

Insp Date: **3/4/08 10:02 AM**

**Location** Address: **31 calverton-smallwood alley**

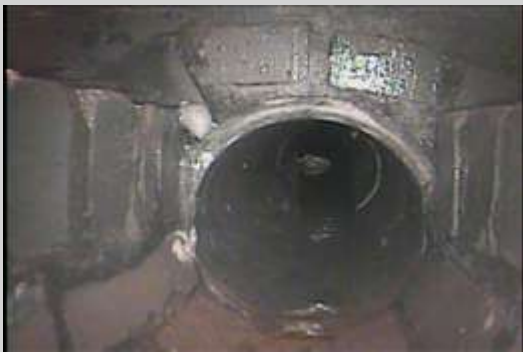
12 O'Clock Outflow

Pipe Height: **8.4** (in.) Rod and Bar (Angled)  
Pipe Material: **Clay** ☐ Pipe Lined  
Invert Depth: **8.93** (ft.) Flow Characteristics: **Slow**  
Deposits: ☒ None ☐ Mud ☐ Sludge ☐ **Debris** ☐ Grease  
Silt Depth: **0** (in.) Deposits Extent:  
Infiltration: **None** Pipe Seal Cond: **Sound**

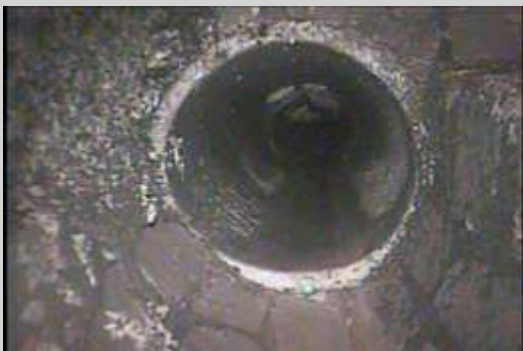
6 O'Clock Inflow

Pipe Height: **7.2** (in.) Rod and Bar (Angled)  
Pipe Material: **Clay** ☐ Pipe Lined  
Invert Depth: **8.19** (ft.) Flow Characteristics: **Slow**  
Deposits: ☒ None ☐ Mud ☐ Sludge ☐ **Debris** ☐ Grease  
Silt Depth: **0** (in.) Deposits Extent:  
Infiltration: **None** Pipe Seal Cond: **Sound**

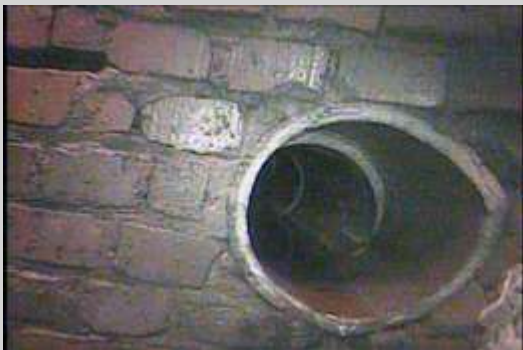
9 O'Clock Inflow

Pipe Height: 8.4 (in.) Rod and Bar (Angled)

Infiltration: None Pipe Seal Cond: Sound
